Purin Hall Renovation Feasibility Study

DFDM Project No. 17B1N
1-8-2018

**Purin Hall Renovation Feasibility Study
DFDM Project No. 17B1N
University of Wisconsin-Milwaukee**

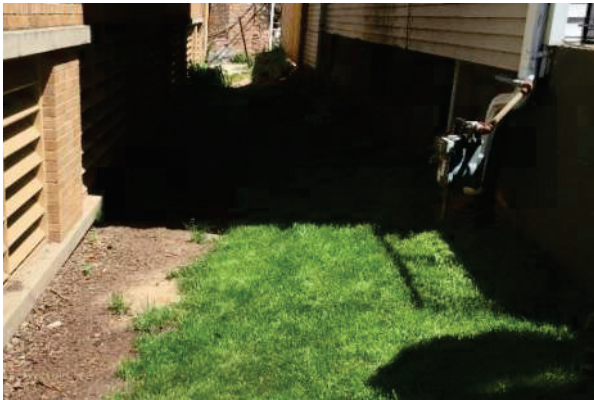
No footings or spread footings are visible. Foundation walls are 8" CMU block with some cracking observed on east elevation and water stains indicating that water has been present on the outside and water is entering at mortar joints. On east elevation, we observed that grade slopes to building. No perimeter drain tile or drainage system was installed around the building. It also appears that adjacent house gutter discharges out on grade (see Photo 1). We would recommend the drain tile to be added along the building on all four elevations especially along east elevations and adjacent property owner discharge his roof drain to storm outlet or away from your building.

Photo 1. Drain from adjacent building discharges out on grade

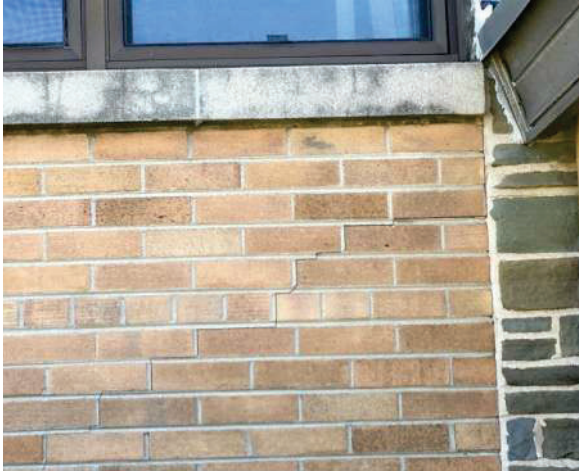
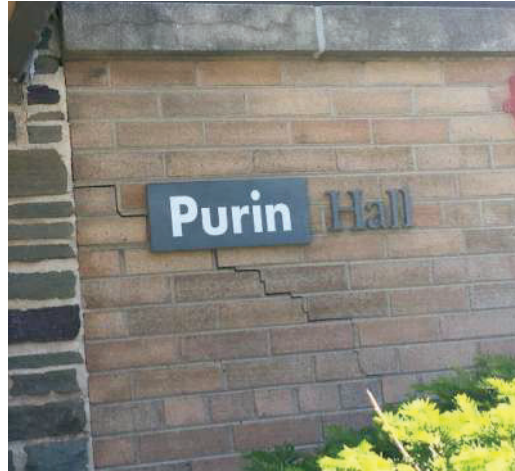
Some minor settlement and cracking was noticed on the foundation walls on the inside of parking garage and lower level. Visual observations of the exterior façade revealed some settlement on the south elevation – See stepped cracks at near south entrance and near roof in SE corner. See photos 2 through 5. These cracks need to be tuck pointed sometime in the near future (two years).

Photos 2-3. Stepped cracks in the exterior brick façade

Visual observations of the exterior façade revealed some settlement on south elevation – see photos 2 through 5 stepped cracks at near south entrance and near roof in SE corner.

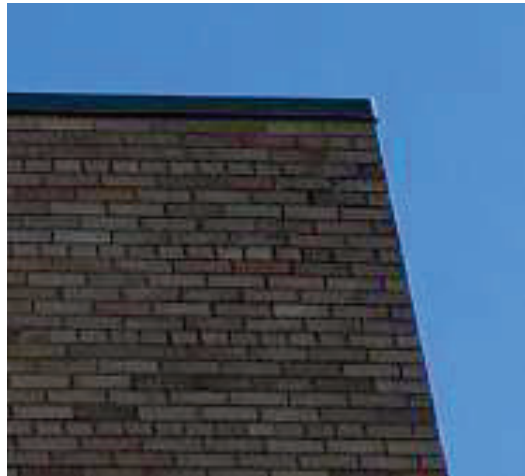
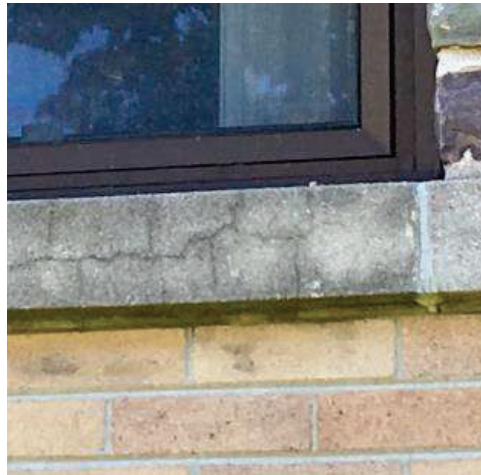
Photos 4-5. Stepped cracks in the exterior brick

Exterior continuous limestone bands above and below windows are showing some hairline cracking. The hairline cracking is due to water being trapped behind limestone and freeze thaw damage has started to deteriorate & crack limestone. The cracked limestone is worse at windows especially below windows, see photo 5.

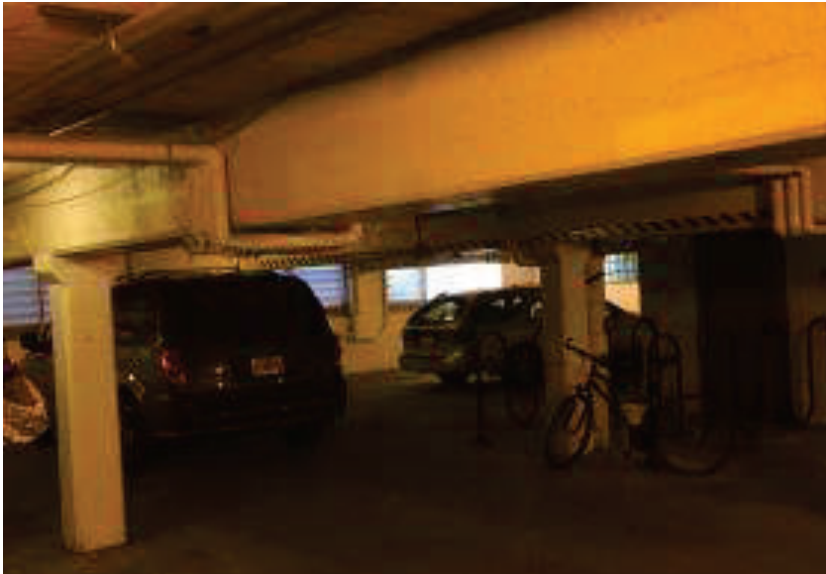
Photo 6. Low ceiling clearance in the garage. Exposed pipes freeze during winter

The parking garage has very low overhead clearance of 6'-0". We would recommend that an option to lower the slab on grade by 1 ft. be explored, so the minimum clearance is 7'-0" under beams. This would also allow room for putting in an insulated ceiling so the pipes do not freeze during winter, which is an on-going problem presently, see photo 6. Ventilation needs to be added to parking garage. Presently the louvers are covered with plastic to keep out the cold, see photo 7. This is a code issue and needs to be addressed.

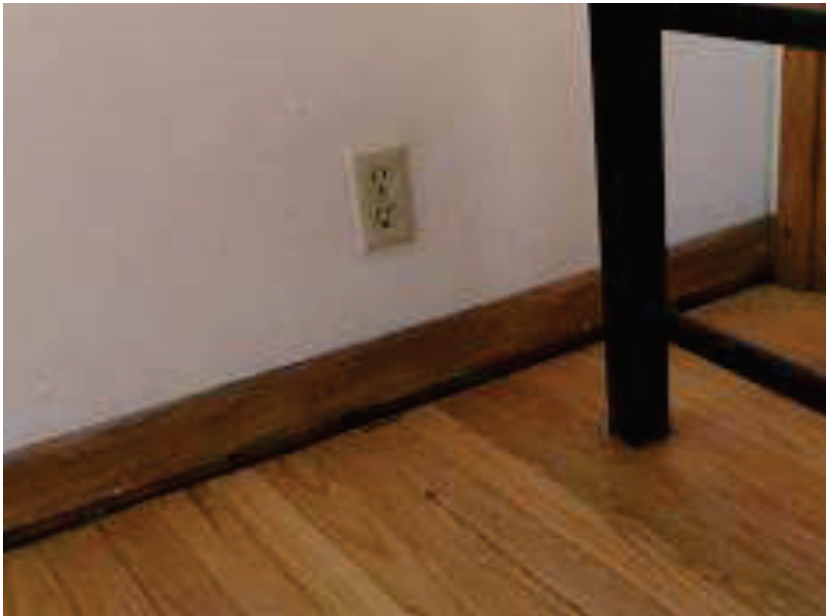
We did observe some settlement on 1st floor, 2nd floor and 3rd floor (1/4" to 1/2"). The settlement is minor for this age of building and can be repaired. See photos 8 and 9.

Photo 8. Settlement on the 1st floor

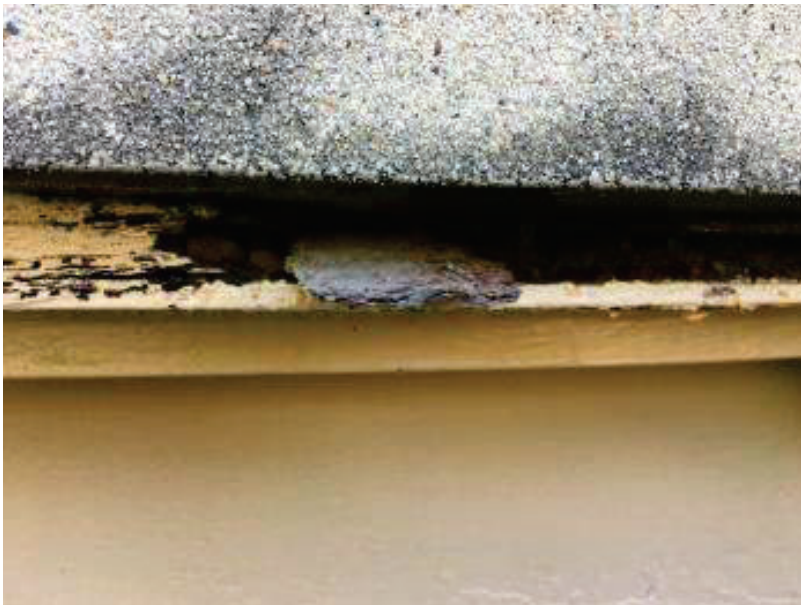
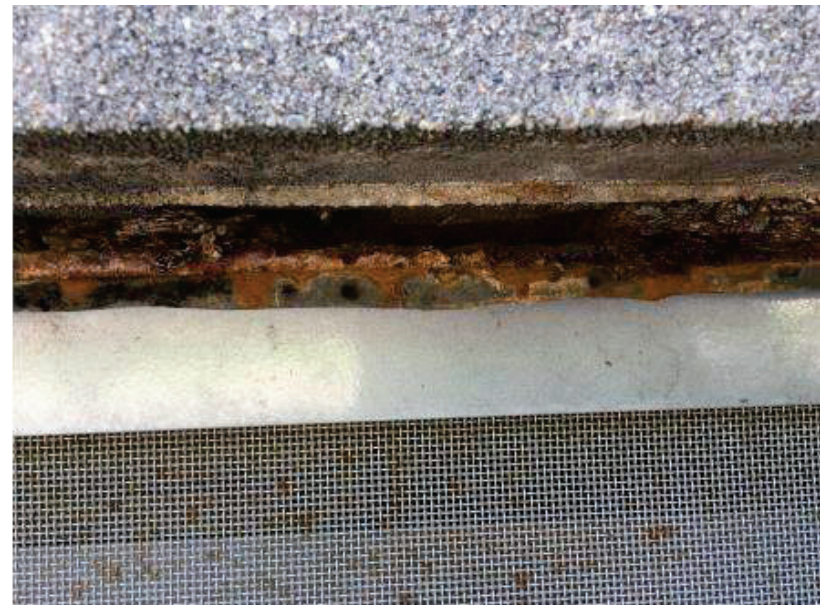
The most significant structural concern was with the steel lintels. The existing building façade was not constructed with weep holes so moisture permeating the brick veneer has no practical means of escaping the cavity between block and brick face. Water is running down back face of brick and exiting out at the steel lintels. The steel lintels are badly corroded and have rust jacked (rotated), see photos 10-11. Four steel lintels have failed and are no longer supporting the brick & limestone bands over window openings. See photo 9 showing failed steel lintel. Some racking of window units is noticeable making windows hard to operate along with fracturing of ceramic window sills. In garage, popping of glass block is evident from steel lintel failure.

Photos 10,11. Examples of rusted and rotated steel angle lintels

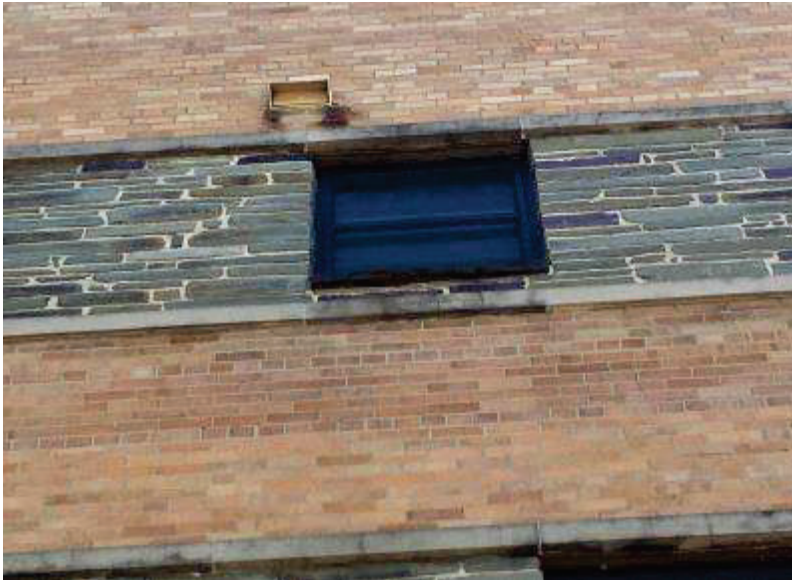
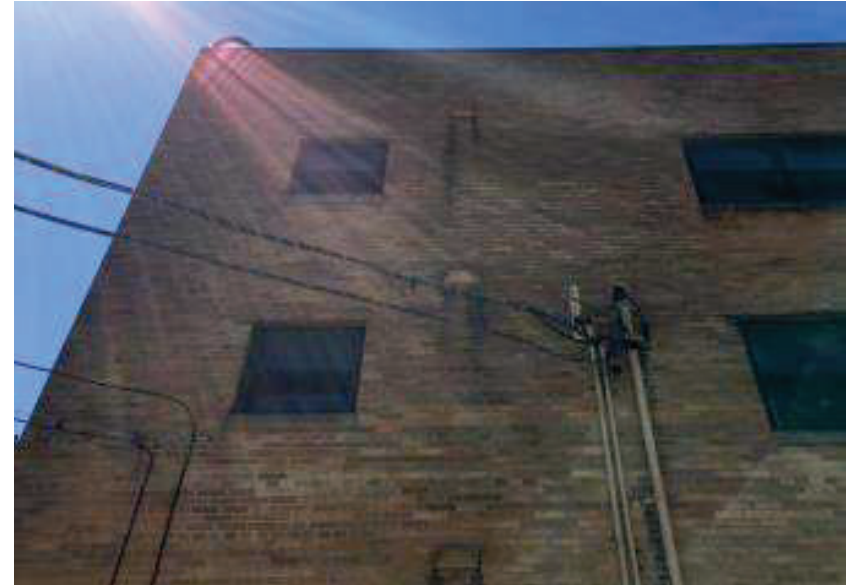
We also observed that bricks were turned 90 degrees every 6 courses. We therefore believe that both limestone bands and turned brick are toothed into 8" masonry back up. This would eliminate the need for steel brick ties. This needs to be verified in the field by removing a 48" x 32" section of brick in two locations to verify if brick and limestone are toothed in and to verify condition of steel angles, see photos 12-13.

Photos 12-13. Examples of brick rotated 90 degrees at the exterior façade

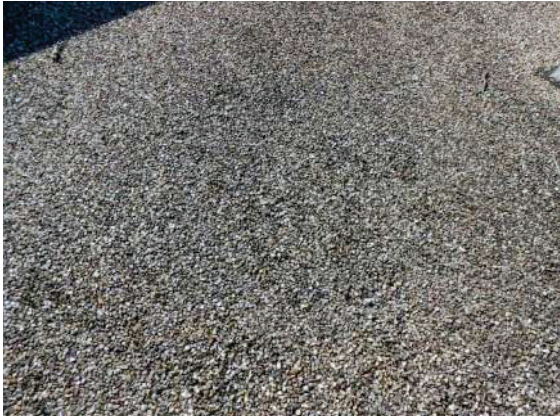
No blisters, soft spots or splits were noted in the field area of the roof, see photo 14. The amount of gravel and embedment of the gravel in the flood coat was adequate. The field membrane could continue to perform for approximately another 5 years with routine monitoring and maintenance.

Photo 14. No blisters or soft spots in the field area

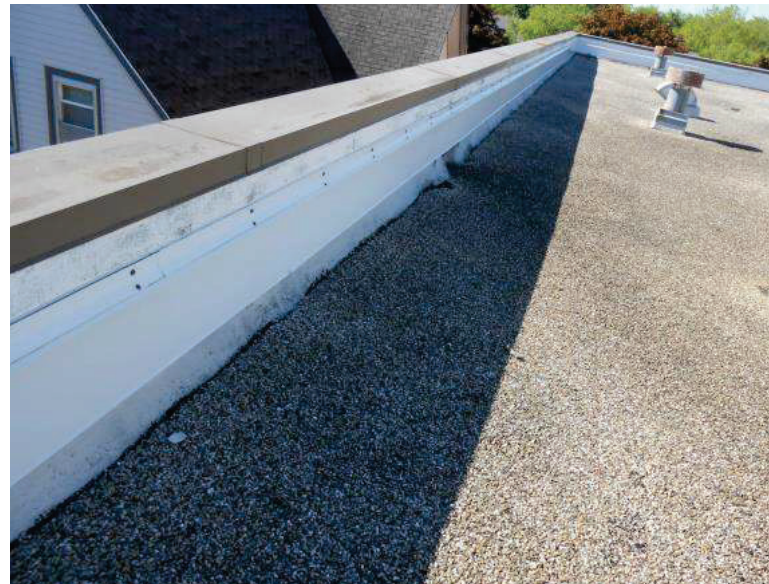
Photo 18. Wall steel coping

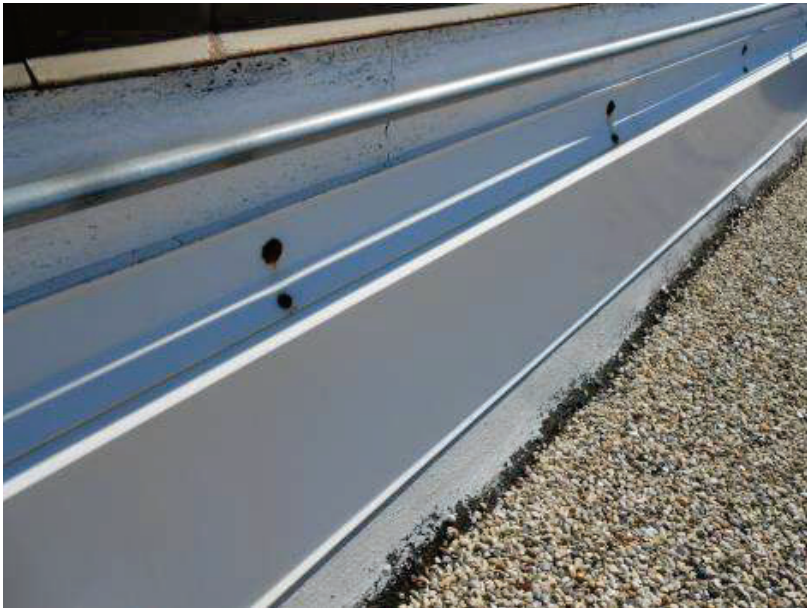
The unusually-tall metal counter flashing and surface-mounted retained appeared sound and covered a large portion of this wall, see photo 19. The condition of the block wall behind the metal is not known. In the short-term, the line of sealant should be inspected routinely and replenished as needed, see photo 20. The defective mortar joints and spalling surface of the block wall should be restored in the short-term to prevent water from penetrating the wall and / or getting behind the flashing components.

Photo 19. Example of metal counter flashing

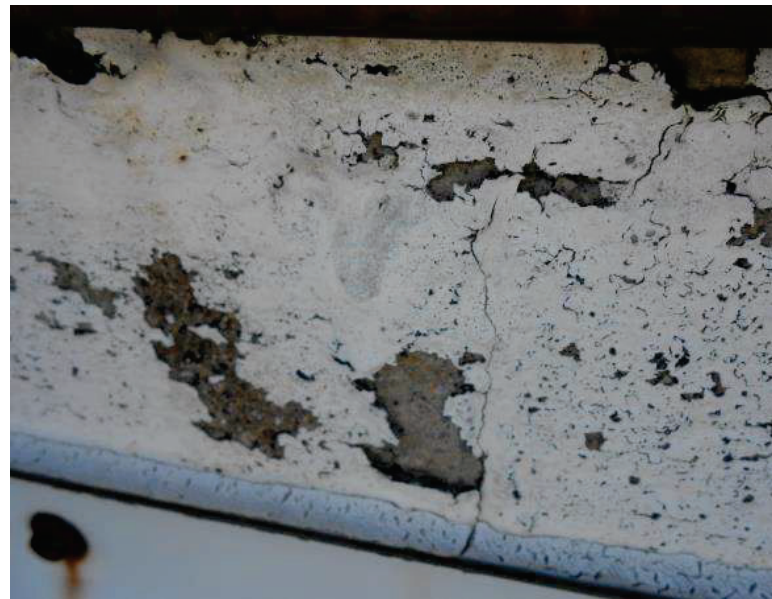
Photo 20. Example of line sealant and spalling surface

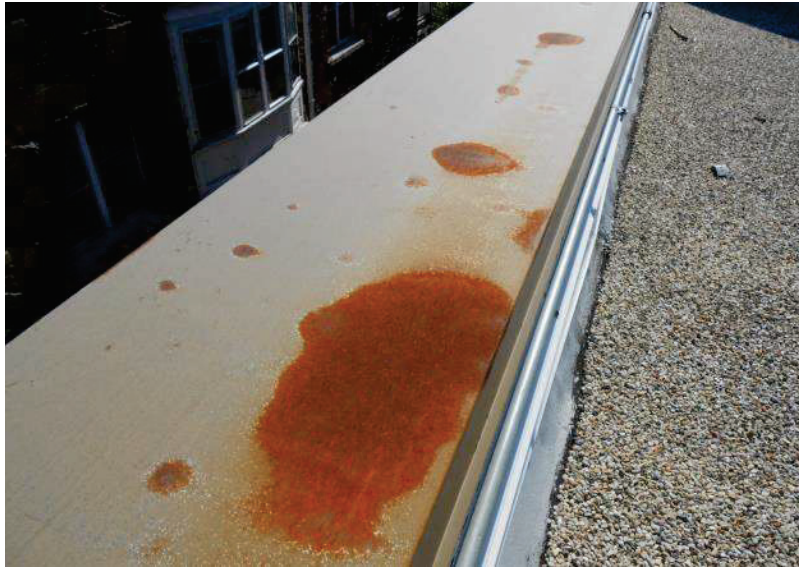
The metal copings anchored to wood blocking likely replaced deteriorated concrete or tile copings atop the parapet walls, see photos 21-22. The metal was fairly secure despite not having full length cleats. A fair amount of corrosion was present. A basic refinishing of the copings could help them perform until the roof system is eventually replaced.

Photo 21. Example of corrosion on metal coping

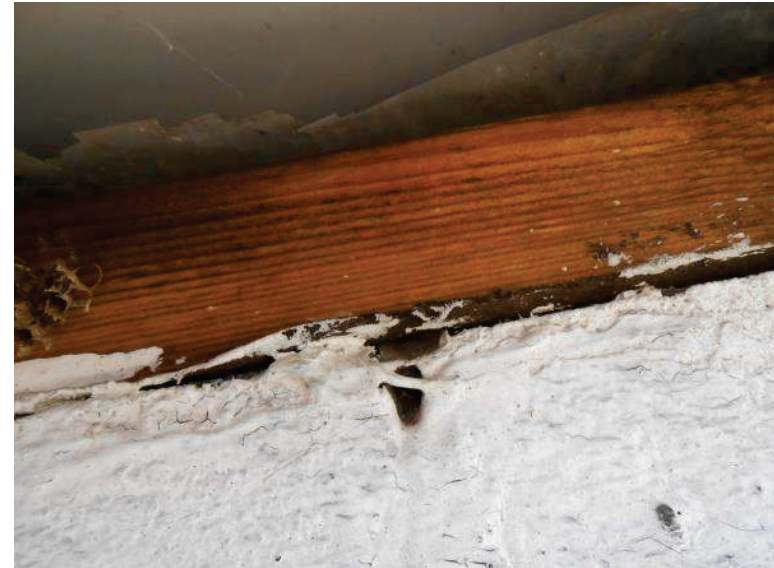
Photo 22. Example of wood blocking under metal coping

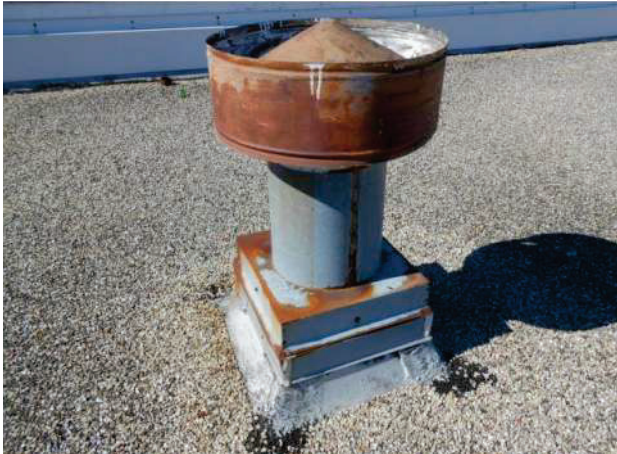
The exposed base flashings surrounding the various vent curbs were mildly deteriorated, see photo 23, and would need restoration similar to the parapet wall flashings to perform in the mid-term. In the absence of perforations from heavy corrosion, the various vents will likely continue to perform until the main roof gets replaced. The flashings surrounding the center chimney appeared sound with the exception of the flashing at the base of the louvered vent panel. The defect needs repair in the short-term. The flashing components around the base of the chimney in the southwest corner of the roof appeared sound. Defective mortar joints in the chimney need to be corrected in the short-term.

Photo 23. Example of flashing surrounding the curb
