Purin Hall Renovation Feasibility Study

DFDM Project No. 17B1N
1-8-2018

**Purin Hall Renovation Feasibility Study
DFDM Project No. 17B1N
University of Wisconsin-Milwaukee**

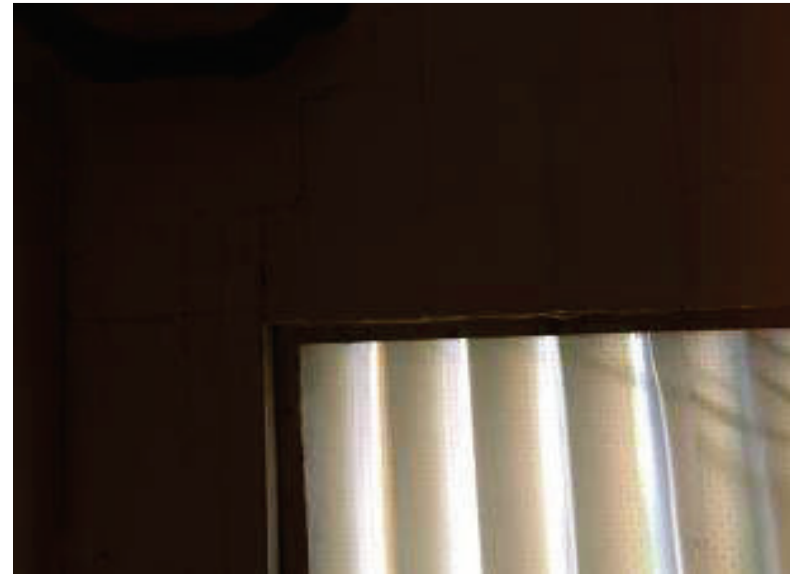
The parking garage has very low overhead clearance of 6'-0". We would recommend that an option to lower the slab on grade by 1 ft. be explored, so the minimum clearance is 7'-0" under beams. This would also allow room for putting in an insulated ceiling so the pipes do not freeze during winter, which is an on-going problem presently, see photo 6. Ventilation needs to be added to parking garage. Presently the louvers are covered with plastic to keep out the cold, see photo 7. This is a code issue and needs to be addressed.

Photo 7. Louvers covered with plastic

- For the basement parking garage, louvers are installed along the north and south side of the building to provide natural ventilation to this area. Since the parking garage does not have any heat, this area is subject to freezing in the winter, so plastic is used to cover the louvers and minimize cold air from entering the garage.

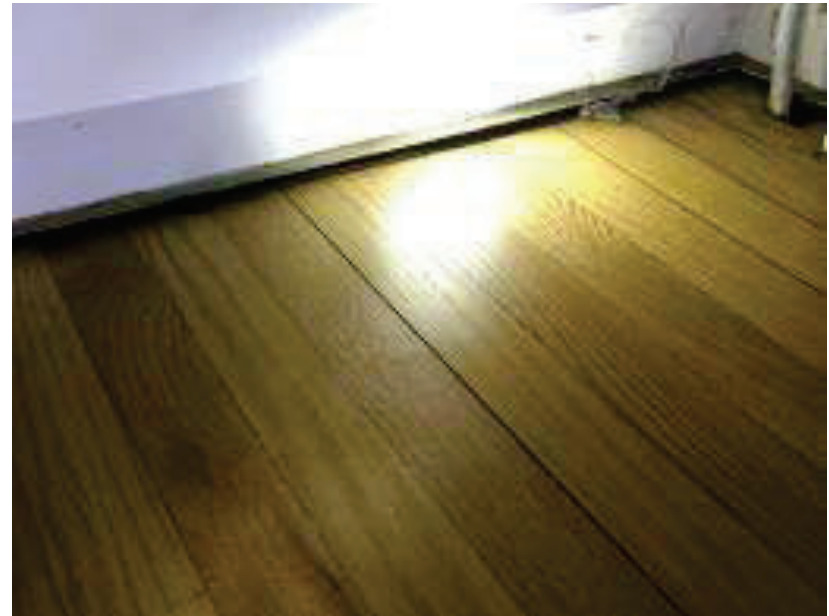
We did observe some settlement on 1st floor, 2nd floor and 3rd floor (1/4" to 1/2"). The settlement is minor for this age of building and can be repaired. See photos 8 and 9.

Photo 9. Settlement at west elevation on 3rd floor

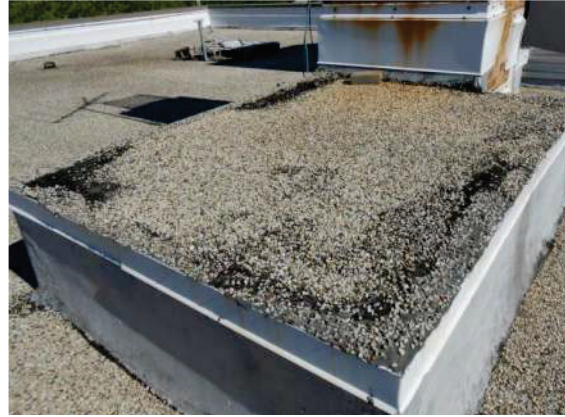
Photo 15. Example of bare spots and patching

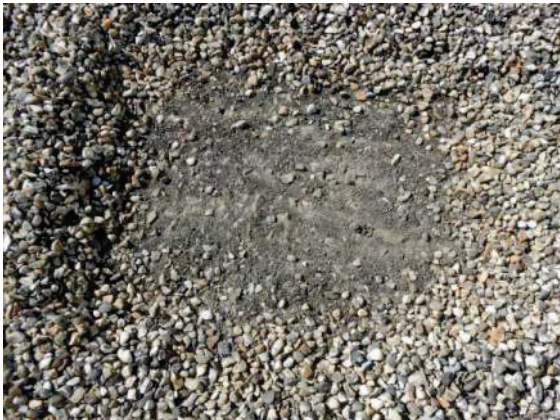
Photo 16. Example of bare spots and patching

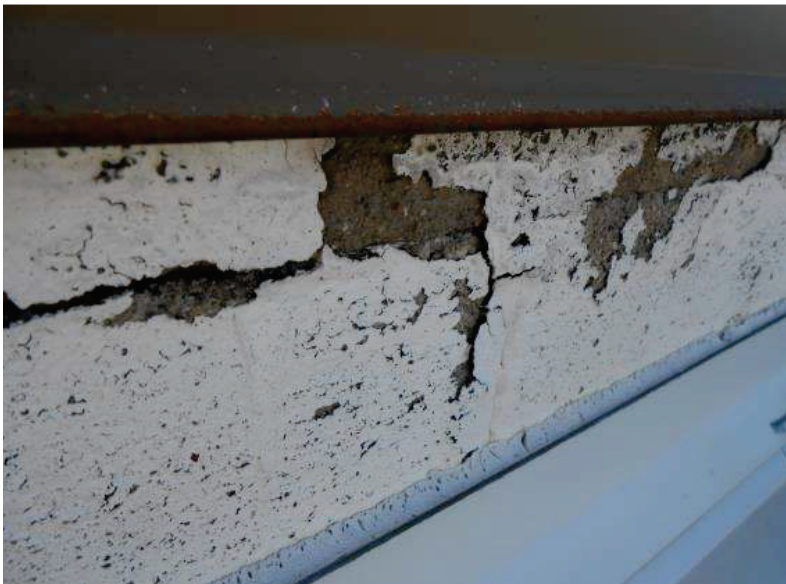
The parapet wall inner surfaces had an aluminum coated composition base flashing, tall pre-finished steel counter flashing and a narrow band of exposed concrete block, see photo 17.

Photo 17. Inner parapet surface construction

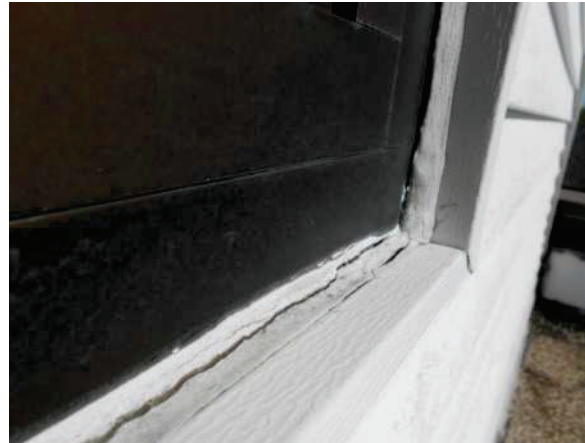
The base flashing around the penthouse was weathered similarly to the balance of the roof flashings. Some of the west-side vinyl siding panels were loose and needed to be re-anchored. The window-to-siding trim seal needed to be replenished to prevent water from getting behind the siding panels, see photo 24.

Photo 24. Example of window-to-siding trim seal

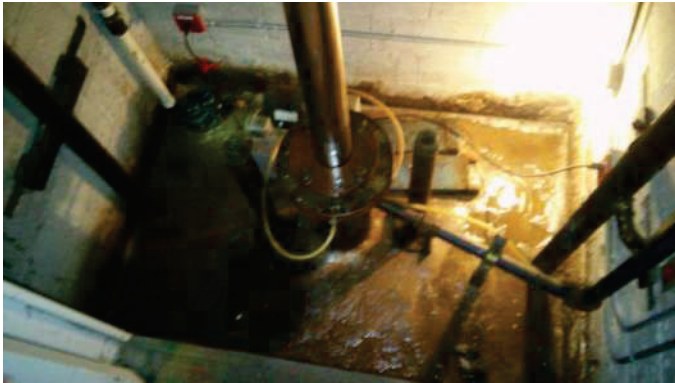
This building has an elevator, but it is the original to the building and is reported to be unreliable. The original manufacturer is no longer in business, replacement parts are no longer available, doors are not automated, and the platform and hoistway are too small to be ADA compliant. The elevator should be replaced and the shaft widened to accommodate an ADA compliant elevator.

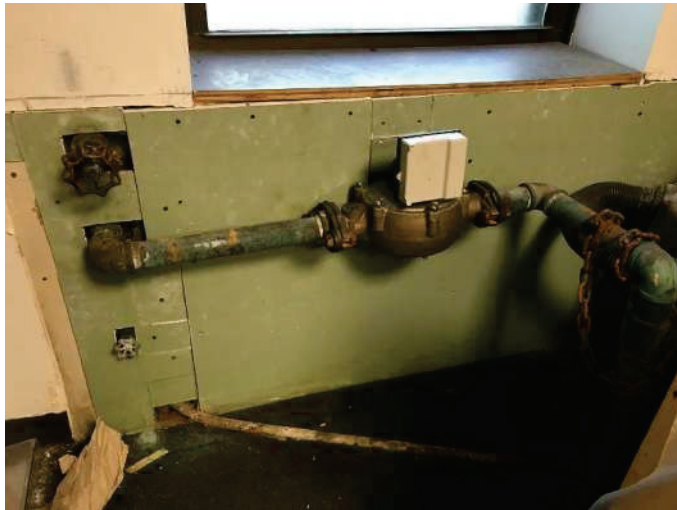
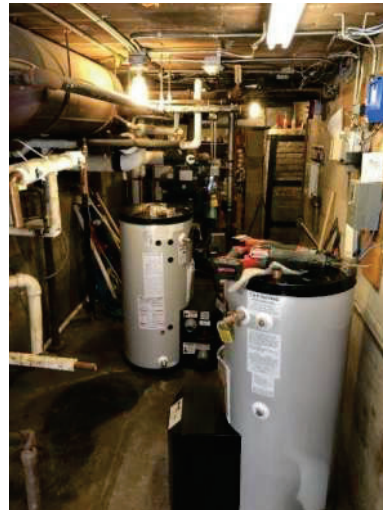
- Building is served by a domestic only 2" water service that enters the basement level in a storage room.
- Water piping is a combination of galvanized steel and copper. The copper is in good working condition but the galvanized steel piping is nearing the end of expected life and has had to have repairs in recent years.
- Two new high efficiency gas-fired sealed combustion water heaters are being installed this summer. Each heater has a 55 gallon storage capacity and a separate storage tank is being installed. The hot water is circulated through the building at 120F.
- There is not a water softener.

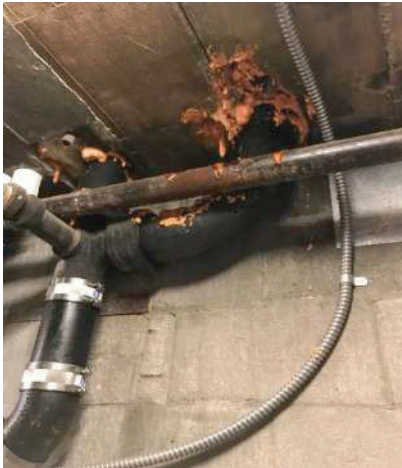
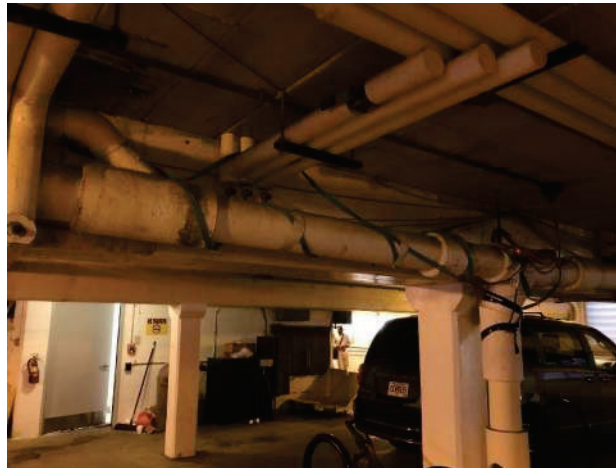
- Sanitary piping is black steel and in fair working order.
- There is a drain in the parking garage but no oil separator.
- Piping routed in the parking garage is subject to freezing and some heat trace has been added to some of the pipes.
- There are no existing drawings indicating size or extent of underfloor piping. If reuse of this piping is explored, additional scoping is recommended to confirm size, configuration and condition. Building does not have any sewage ejector pumps and is served by gravity. No known issues with sanitary blockages in system and piping is original to the building.
- D2030Storm
- Roof drainage is a combination of piped roof drains, roof scuppers, and downspouts.

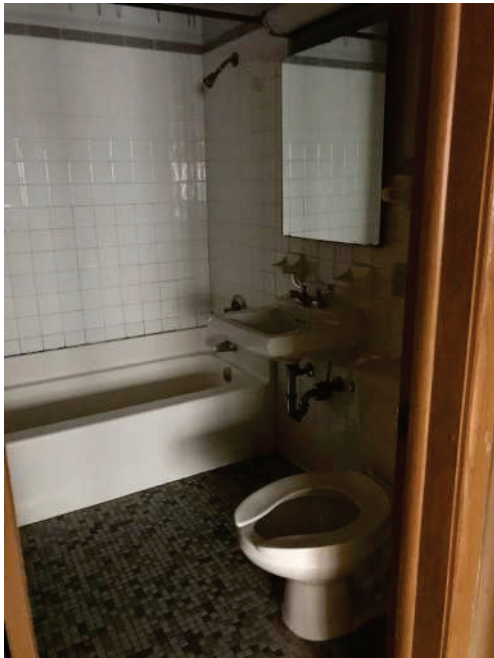
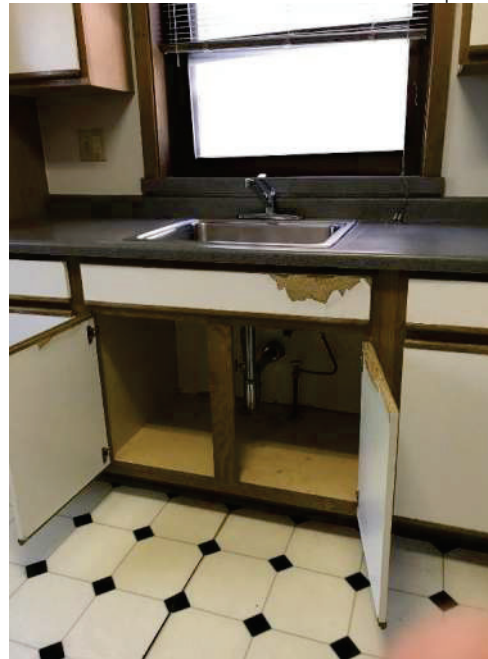
- Plumbing fixtures are original to the building and do not meet current water conservation requirements.
- Kitchen sinks do not have garbage disposals and are located at exterior walls and are subject to freezing in winter.

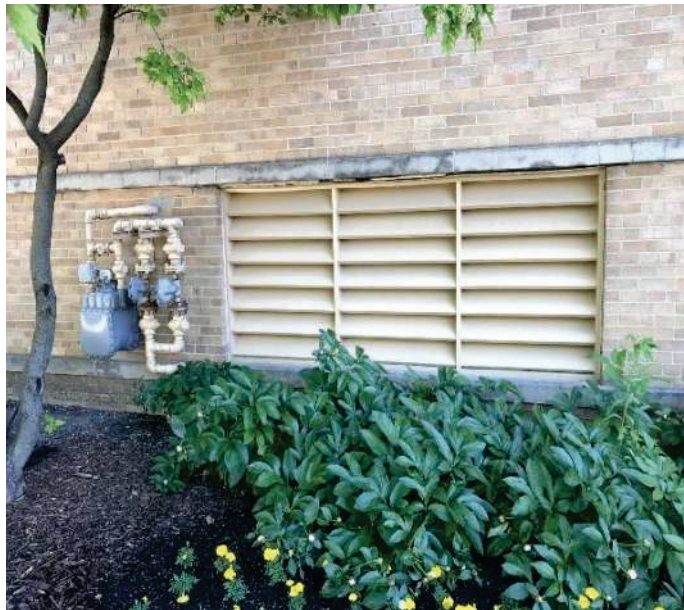
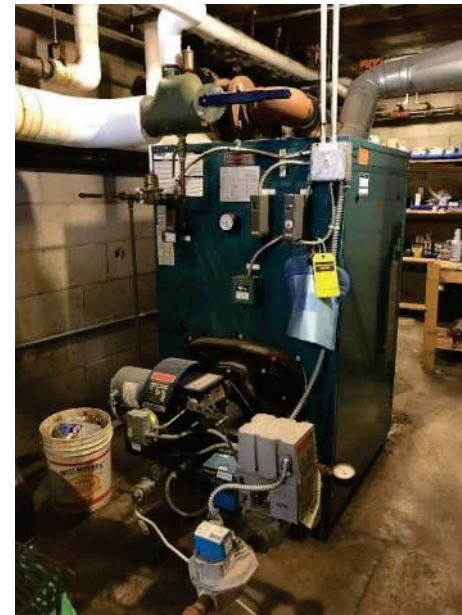
- Heating equipment is gas-fired. Gas meter is located outside near the parking garage entrance on the south side of the building.
- Building is served by a single steam boiler that was installed in 2006. The boiler is in fair condition but not as efficient as newer sealed combustion condensing style boilers.
- There are no steam traps installed at terminal equipment, so system has frequent air issues that have to be addressed as an ongoing maintenance issue

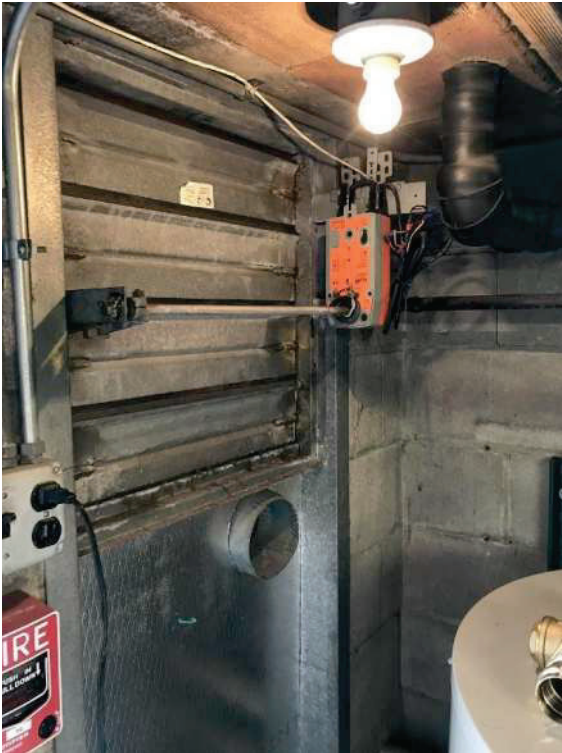
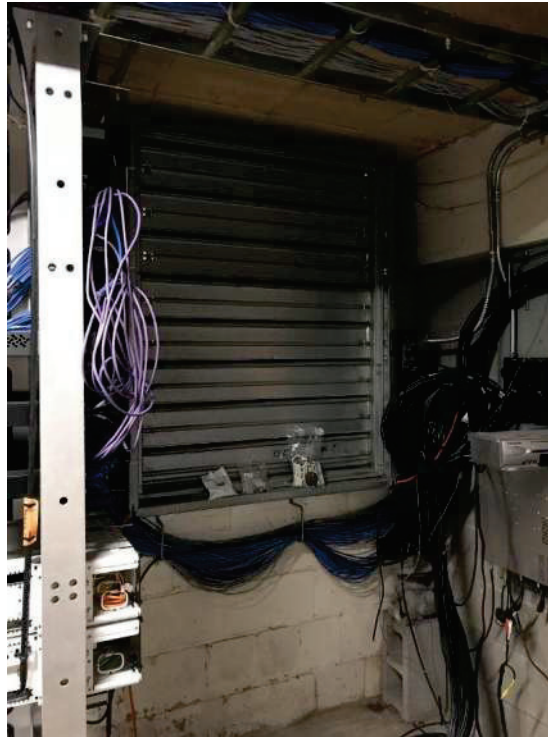
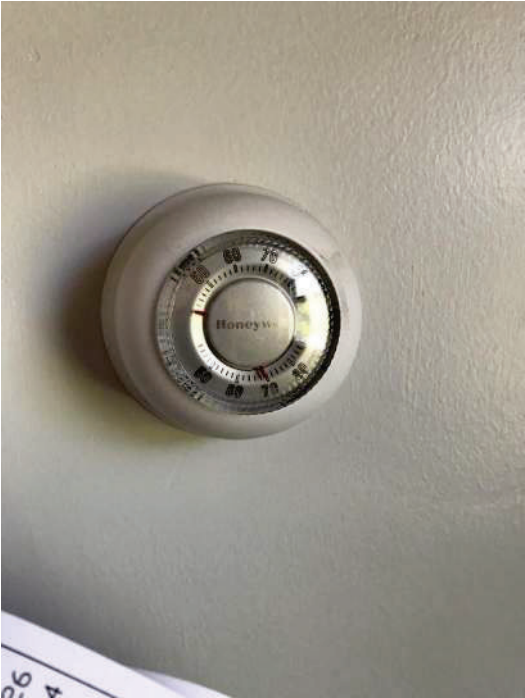
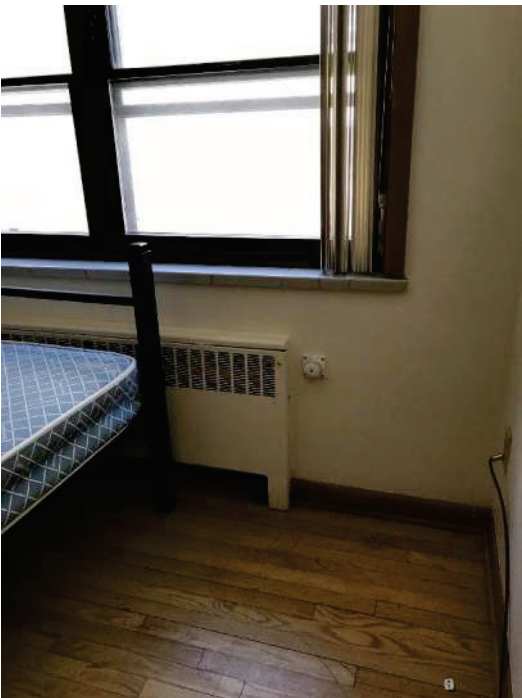
- The building is controlled by pneumatics with a few electronic damper controls serving the emergency generator and combustion air to the boiler room.
- There is a single thermostat located on the upper floor that serves the majority of the building. There is a single room convector heater on the first floor above the boiler room that has its own thermostat. There are frequent complaints concerning temperature control and windows are frequently opened during heating season to address lack of temperature control from building controls.

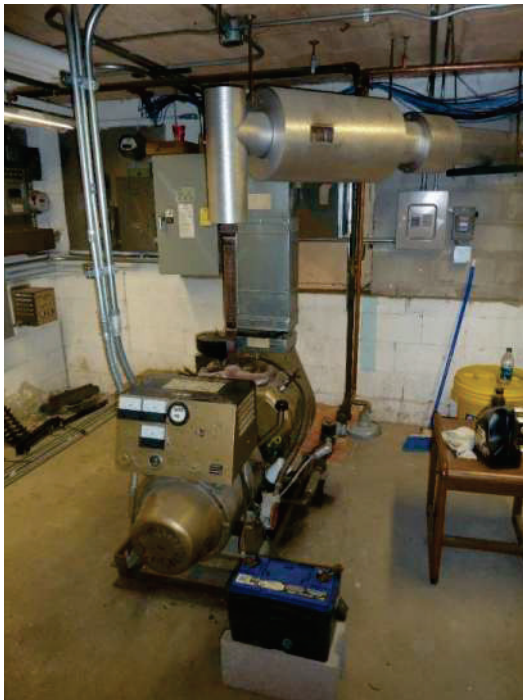
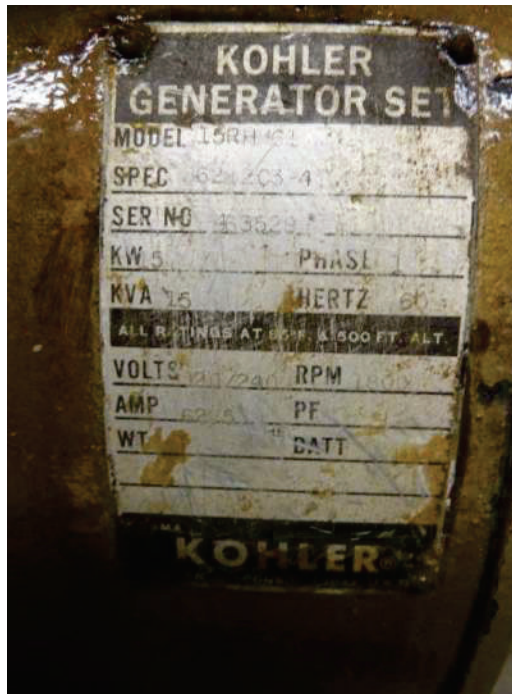
- D5010 Building Power Generation D5010.1 Generator
- The emergency generator is 15KW, 120/240V, single phase, natural gas, and located in the lower level electrical room.
 - The generator is nearing the end of its useful life.
 -

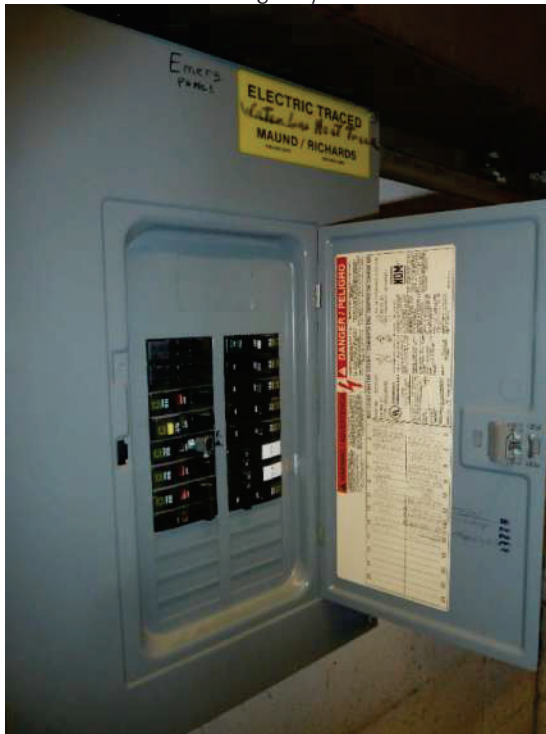
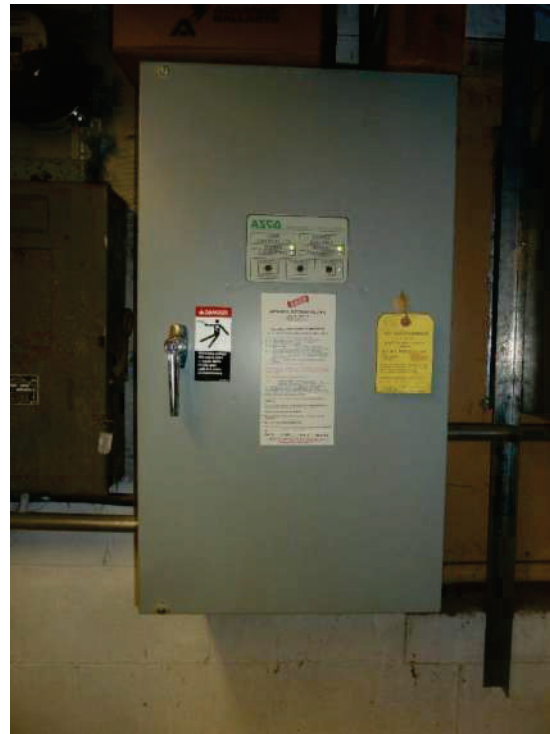
- The generator feeds an automatic transfer switch and 24 circuit load center which serves all emergency loads in the building.
- The ATS and load center are not original and are in good condition.
- As constructed the emergency load separation would not meet current code at the existing load center. NEC 700 emergency loads are fed from the same transfer switch and panel as NEC 702 optional loads (boilers, sump pump, etc.).
- As constructed the selective coordination arrangement would not meet current code at the existing overcurrent devices serving emergency loads.

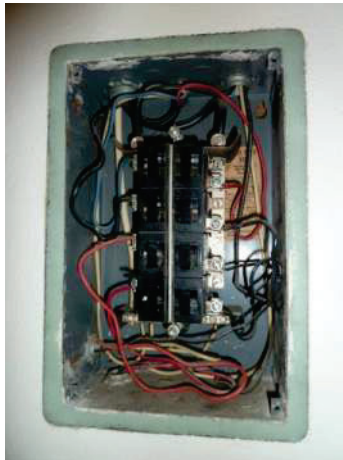
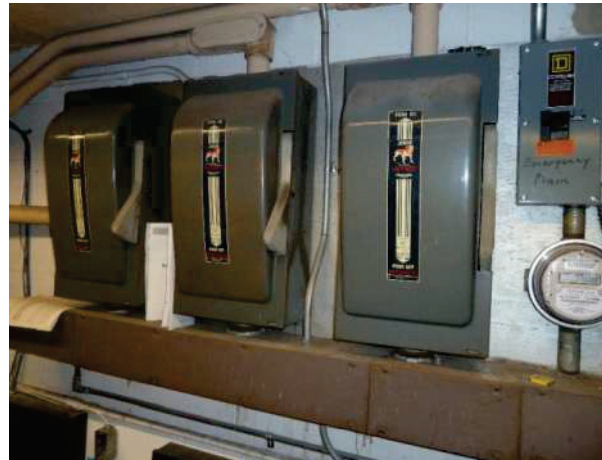
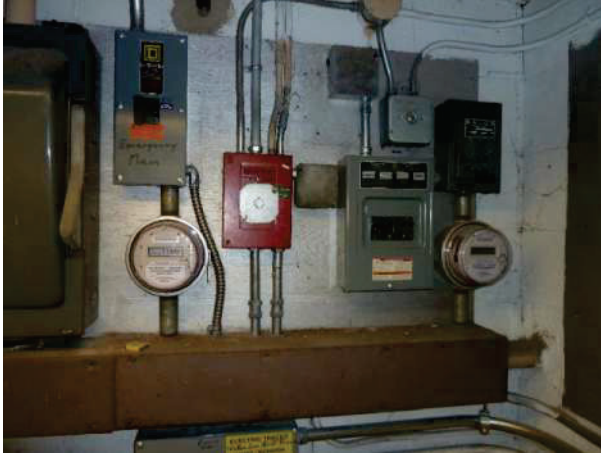
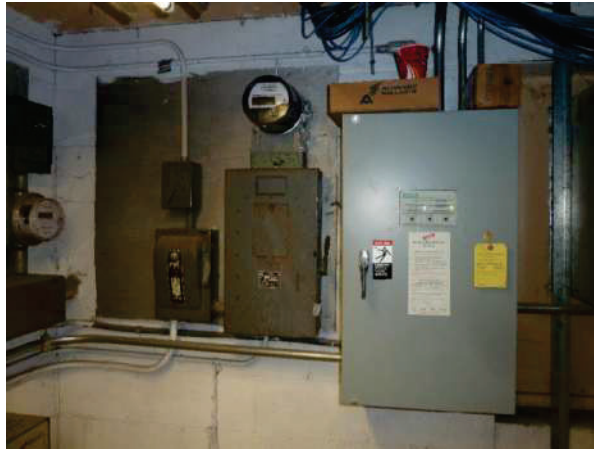
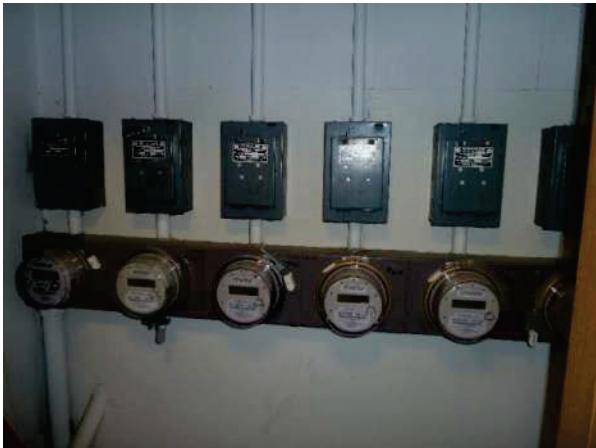
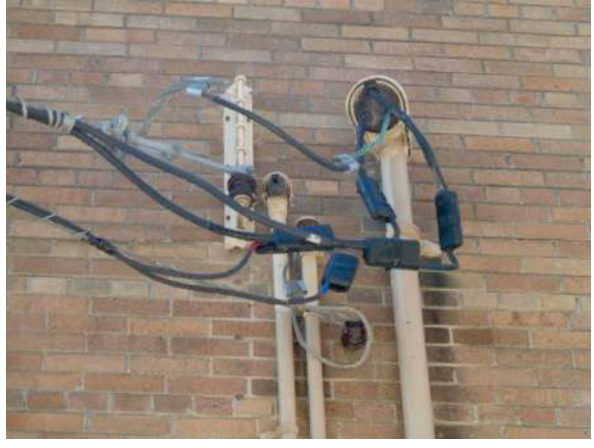
- Two overhead services enter the building in the lower level electrical room. One service is 120/240V, single phase, 2 pole, 3 wire and feeds three 200A service disconnect switches. The other service is 120/240V, single phase, 2 pole, 3 wire and feeds the elevator.
- Metering is separated for each resident unit, the elevator, the emergency feeder, and “house” power.
- Each resident unit has a dedicated load center in a closet. All load centers on one floor are fed from one of the 200A service disconnects.
- All normal electrical distribution equipment is original and at the end of its useful life. Spare parts are not available for most equipment.
- Equipment grounding conductors are not present in branch circuits or feeders. This could result in poor grounding at panels and devices.
- Conductors in
- Load centers in resident units do not have required working clearance in front of them.

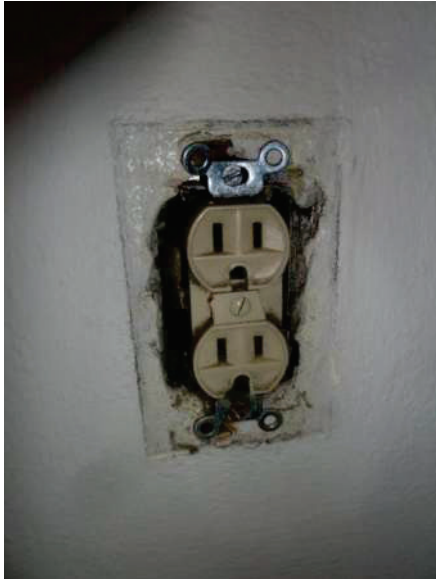
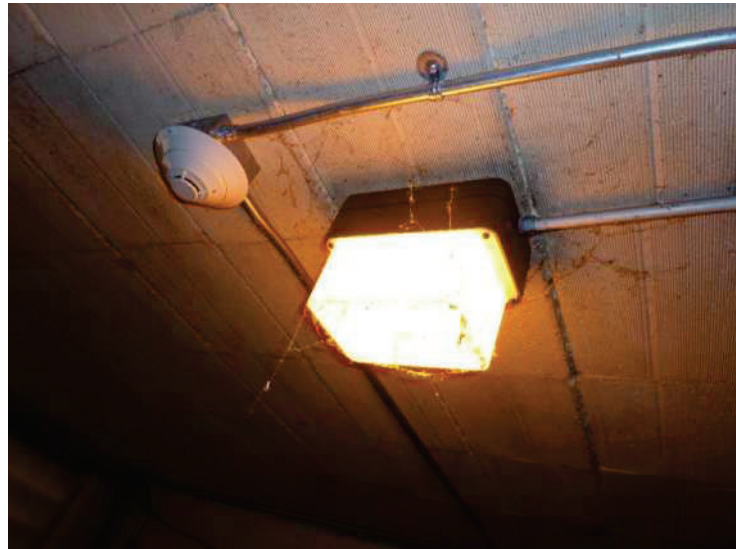
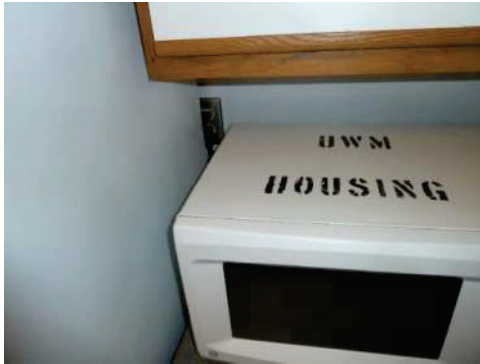
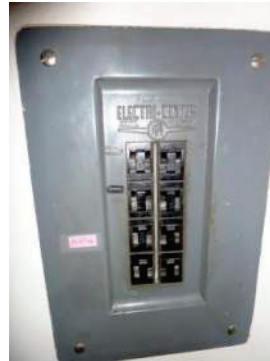
- The number of branch circuits in the resident units does not meet current code. This includes the microwave and refrigerator circuited to the same breaker or plugged into the same receptacle and causes circuit overloads.
- Receptacle spacing in resident units does not meet current code.
- Some 15A circuits have 20A receptacles circuited to them and do not meet current code.
- Some two pole breakers in load centers do not have code required breaker ties.
- Branch circuit breakers in resident units do not have arc fault protection, which does not meet current code.
- Receptacles in the resident units are not tamper-resistant, which does not meet current code.
- Elevator branch circuits and overcurrent protection do not meet current code.

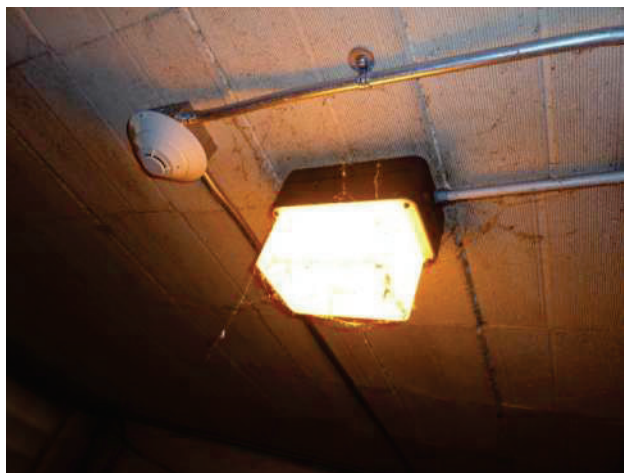
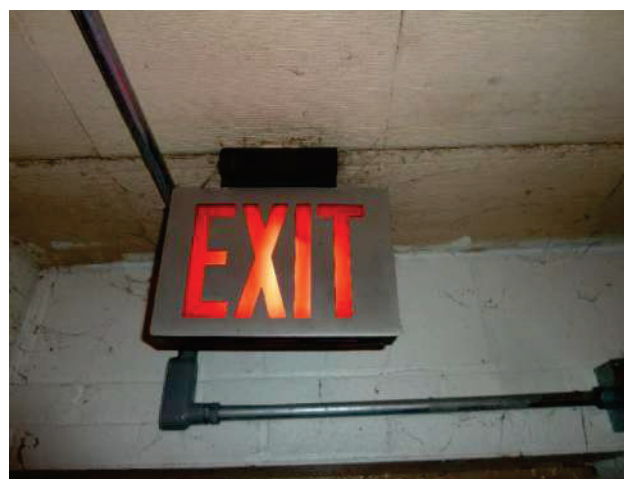
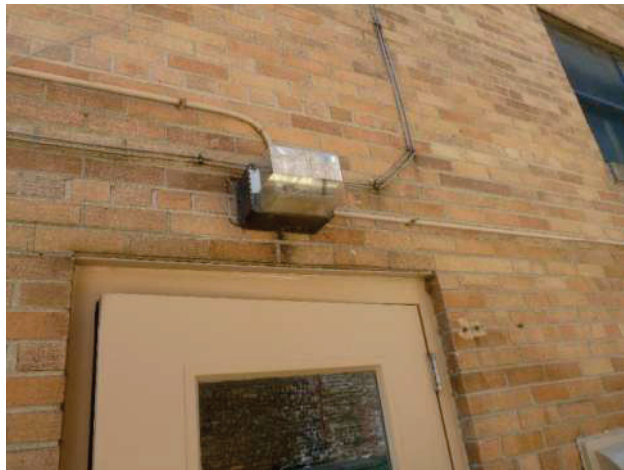
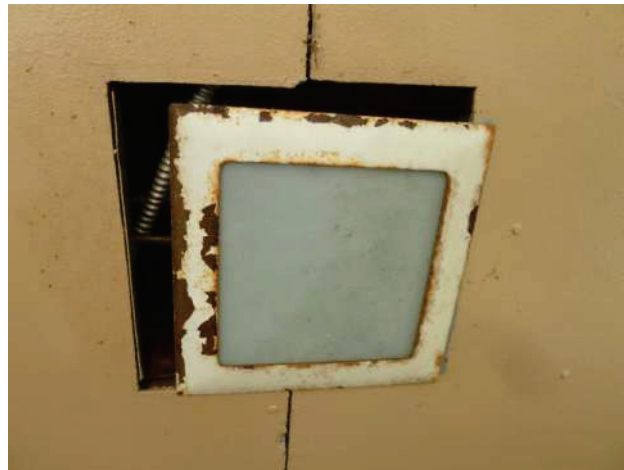
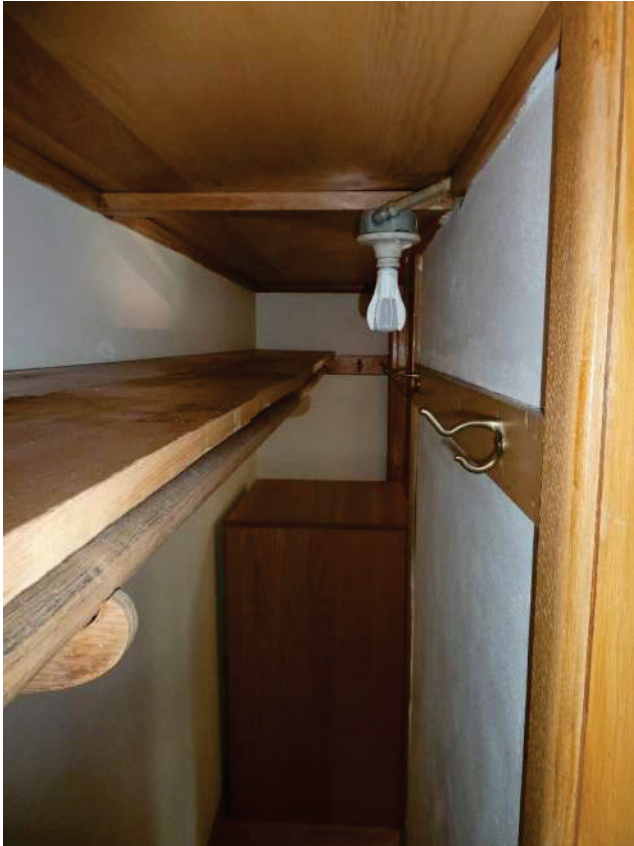
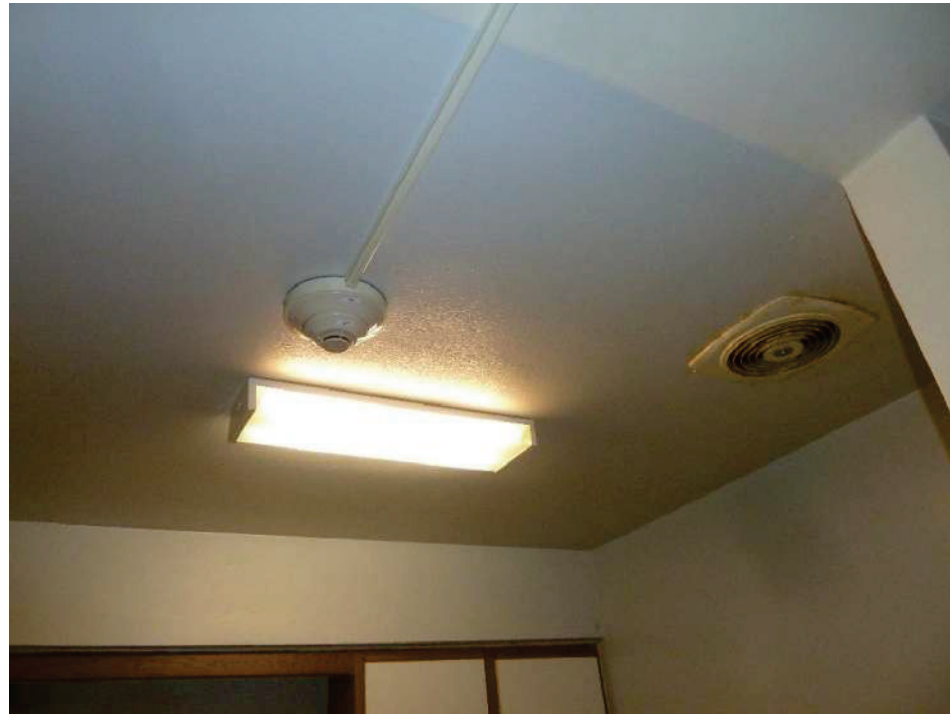
- Exit signs are incandescent type.
- Most light fixtures are original or in poor condition and are at the end of their useful lives.
- Footcandle levels for normal power egress path illumination in stairs and corridors do not appear to meet current code.

- Light fixtures and a timer switch are installed in one of the third floor bathrooms. The light fixtures and switch do not appear to be listed for this application.

- Lighting watts/square foot levels do not appear to meet current energy code.
- Light levels throughout the building appear to be below IES recommended minimum levels.

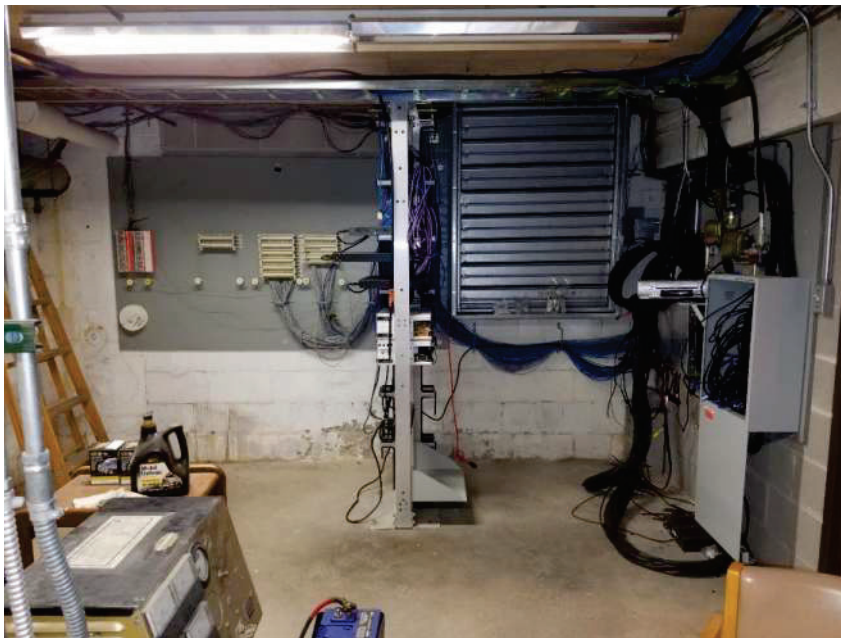
- Existing Owner furnished equipment includes Wireless Access Points (WAPs) located in various rooms and spaces throughout the building and server/local area network (LAN) gear located in the telecom room.
- The LAN equipment is located in an unconditioned area in the lowest area of the building, it is located in shared space with electrical equipment (and a generator) and is not protected from dust, or other elements. The location of the equipment and the unconditioned space will contribute to the premature failure and demise of Owner's electronic network equipment.
- Existing pathways consist of exposed, surface mounted, 4" conduits for major cable distribution routes, chases to resident rooms and surface raceway for routing voice/data and/or coaxial cables to final location(s).
-

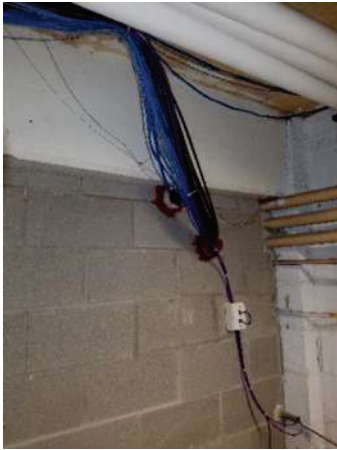
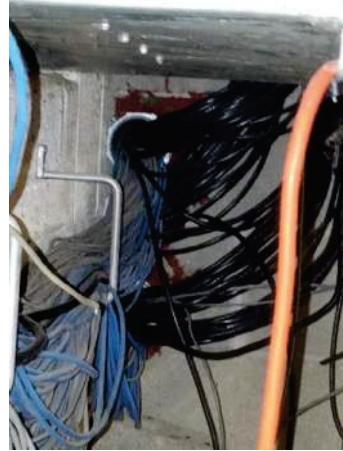
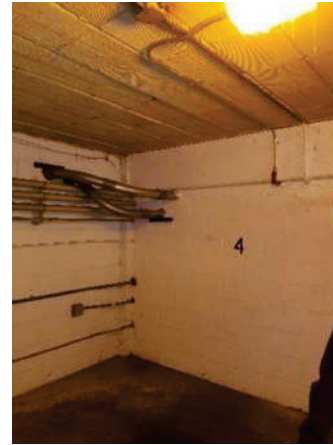
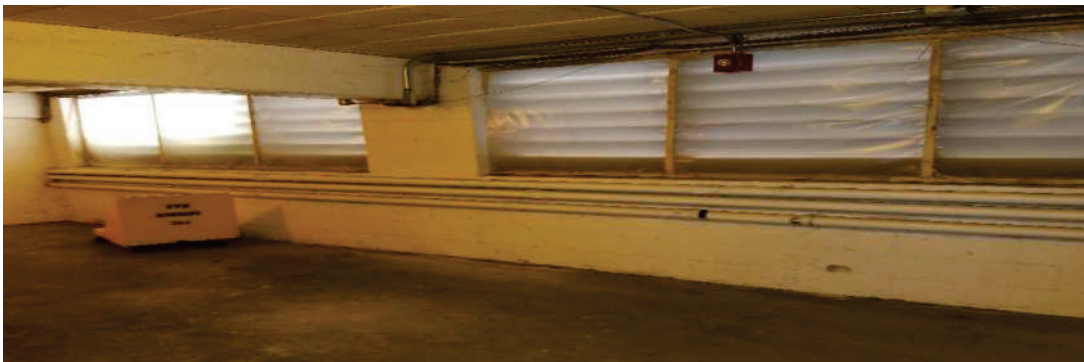
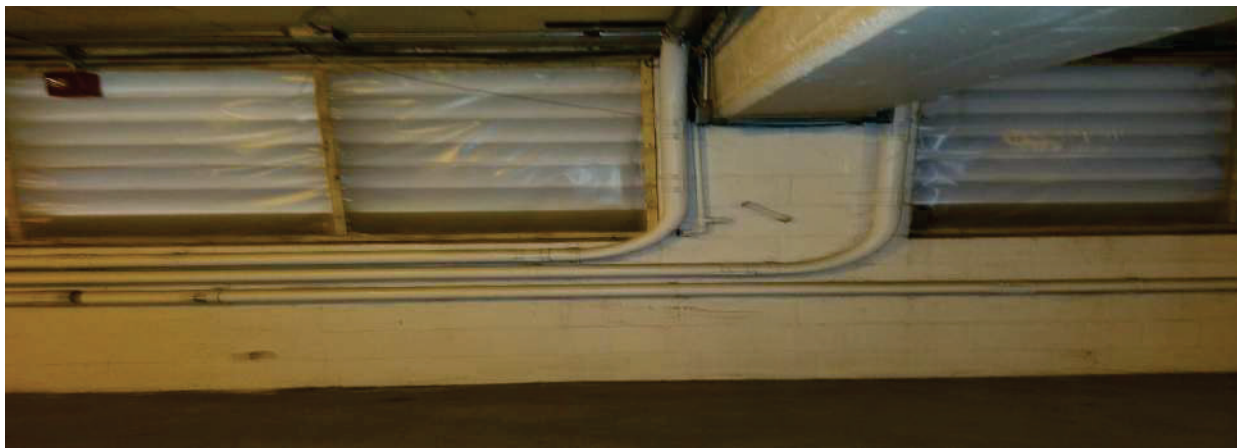
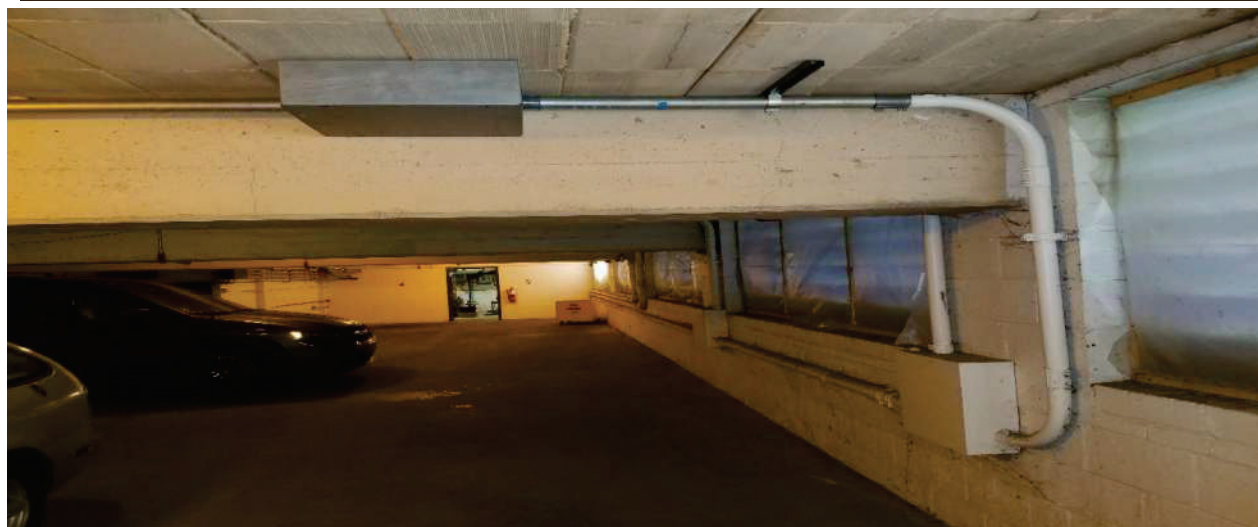
- Location of telecom room undesirable, shares space with electrical equipment (including backup generator) and is exposed to dust and temperature extremes due to unconditioned space. Room also shows signs of water erosion on walls. Not recommended for support of new/upgraded technology equipment head end equipment.

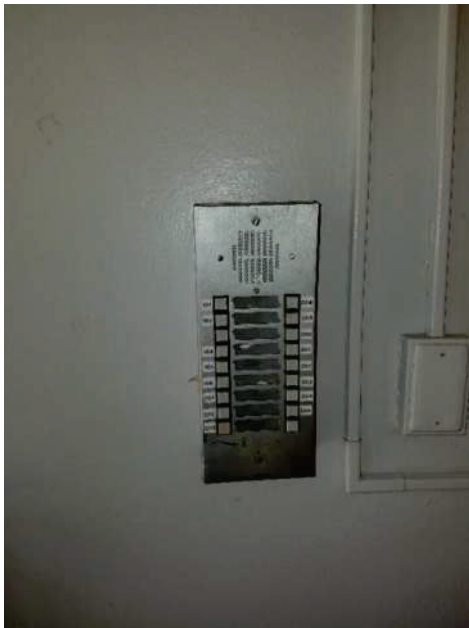
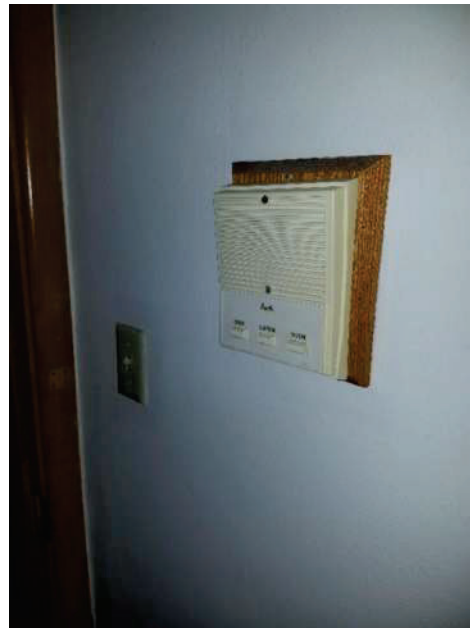
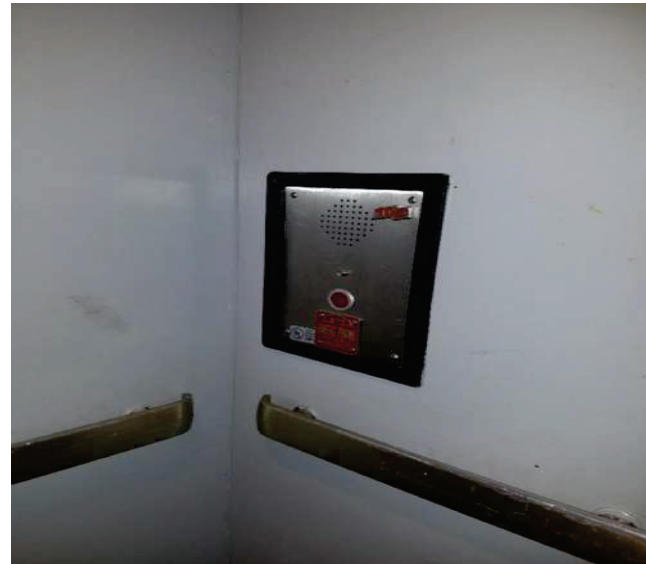
- Tenant visitor entry system includes master panel at main lobby and an individual intercom to each resident room for guest entry access. The system appears to be original to the building and does not work. Recommend replacement of intercom system.
- Emergency Phones (1) at Main Entrance and (1) in Elevator. Phones appear to be original to building, or are of considerable age and possibly nearing end of life. Replace.

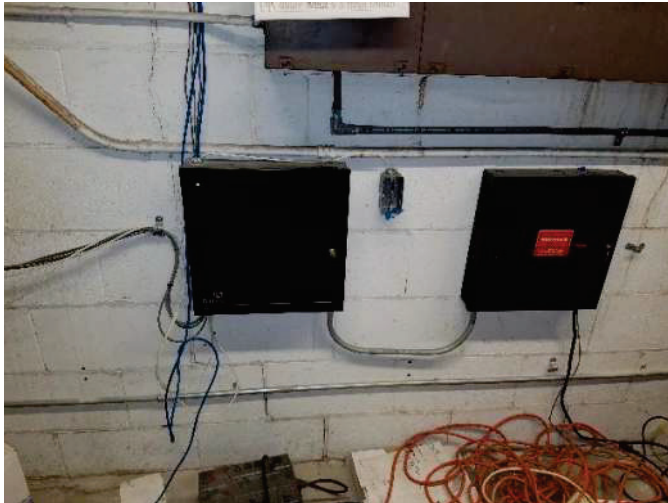
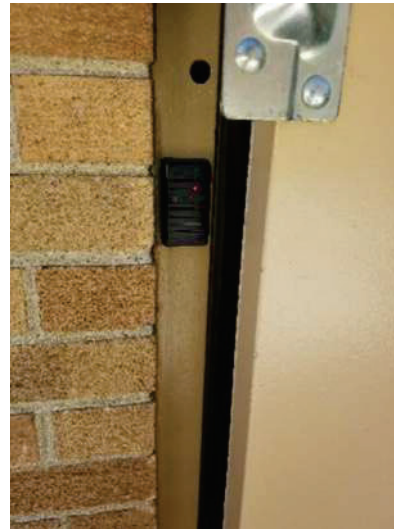
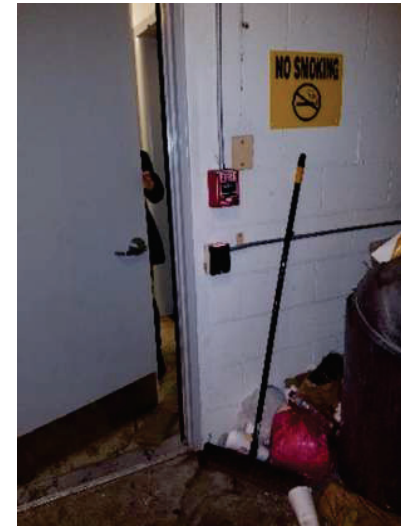
D7010 Access Control & Intrusion Detection Systems

- Existing system is an Access Control System only. No intrusion detection component(s) found.
- System includes credential readers (CR) at each exterior entry door to the building and a CR at the interior garage entry door leading into the common corridor of the residence space.

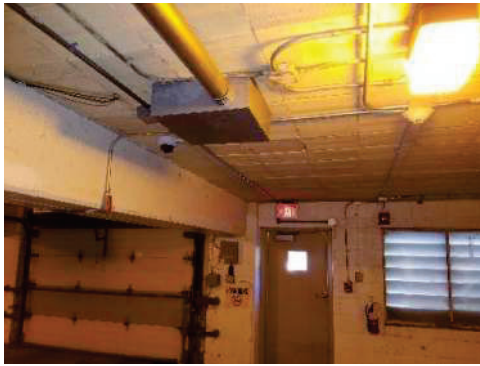
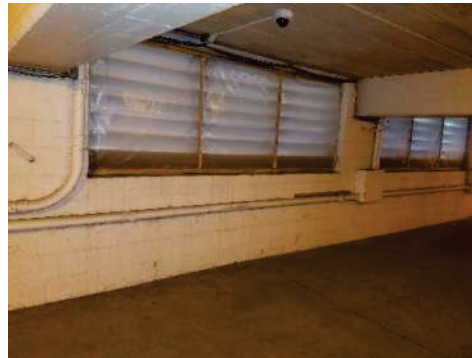
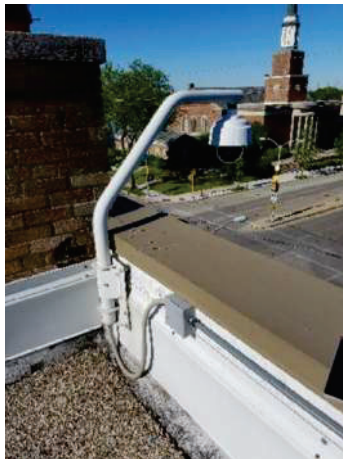
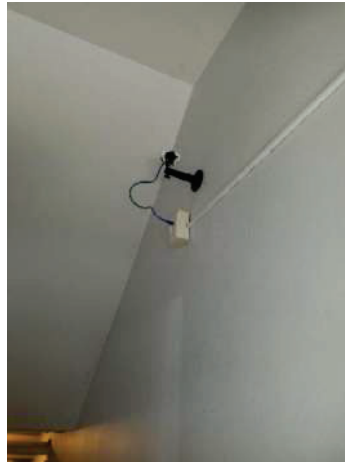
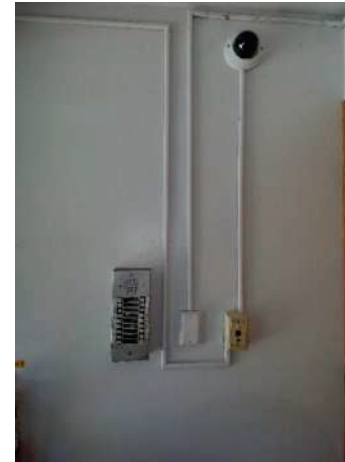
D7030 Electronic Surveillance

- Building has (5) IP surveillance cameras (approximately 5 years of age or older). Cameras monitored off-site by UWM PD. Could not assess camera functionality or resolution due to off-site monitoring station. Cameras appear to be in fair condition and functioning.

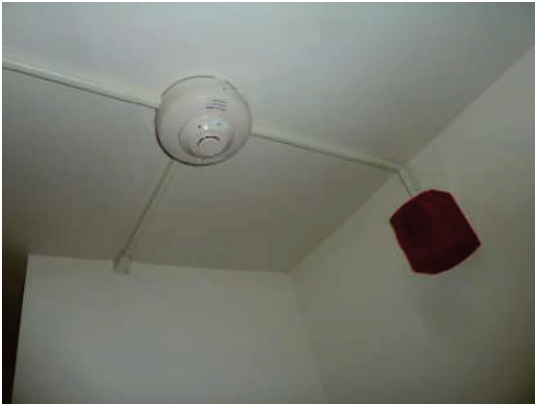
D7050.10 Fire Alarm

- A Notifier addressable fire alarm panel with voice notification is located in the main vestibule.
- Smoke detectors are located in most common/public spaces of the building.
- Smoke alarms are also provided in resident units.
- Notification devices are provided throughout the building.
- Pull stations are located at exits.
- The fire alarm system was replaced and updated in a 2012 project. All equipment.
- Smoke detection and fire alarm interface for elevator recall and shutdown is not present per current code.
- No fire alarm devices are present in the attic space.
